# Collision with terrain in dark night conditions involving Robinson R22 helicopter, VH-YPC

70 km north-west of Halls Creek, Western Australia | 25 August 2014

**ATSB Transport Safety Report**  
Aviation Occurrence Investigation  
AO-2014-144  
Final – 16 December 2014

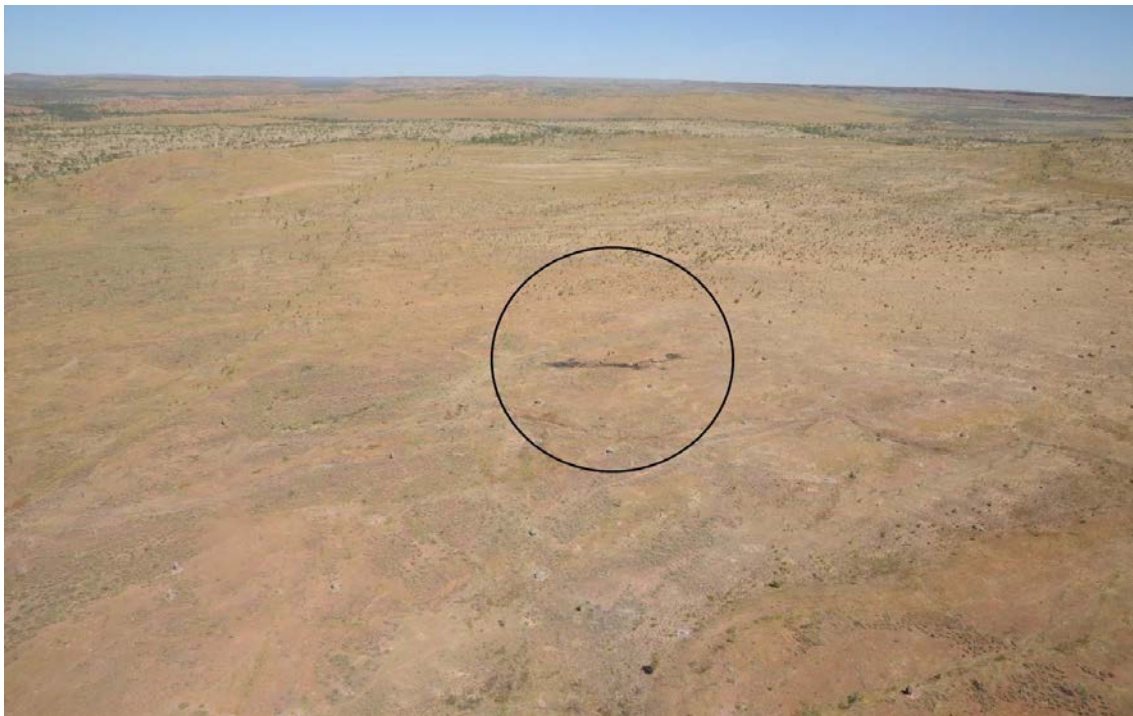
**Figure 2: Overview of accident site (circled, from the north)**

The following helicopter did not arrive in the expected timeframe and, after various attempts to contact the pilot, the authorities were alerted that night. At first light the next morning the station pilot at Springvale and the R22 pilot at Leopold Downs were tasked to fly along the direct track to search for the overdue helicopter. Another helicopter pilot joined the search and at about 0700 a burnt area and accident site was located (Figure 2). The station manager was fatally injured and the helicopter was destroyed.

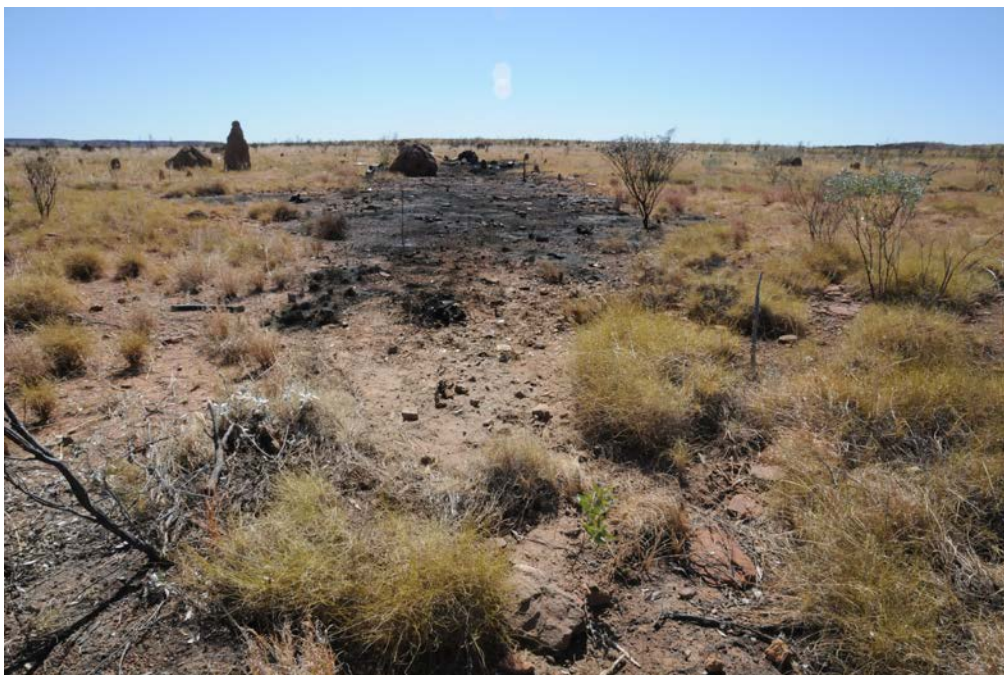
**Figure 3: Wreckage trail with initial ground impact in the foreground (looking west)**

The accident site was on hard flat land, 25 NM (45 km) to the west of Springvale and just north of the direct Leopold Downs-Springvale track. From the initial impact point the wreckage trail and post-impact fire damage extended to the west, generally opposite to the expected direction of travel. The wreckage was distributed over an area of about 50 m long and 12 m wide.

The cockpit/cabin was severely disrupted early in the sequence, leaving the airspeed indicator captured near the 100 kt marking. The forward part of the left skid was also broken off early in the sequence while the corresponding right skid remained attached to the main skid-landing gear assembly.

The tail boom was detached as an assembly and located past the main wreckage. There was no evidence of a main rotor blade strike to the tail.

Both main rotor blades were still attached to the hub. Each was severely damaged with part of one blade torn off and located near the main wreckage.

The wreckage trail and damage pattern were consistent with a high-speed impact with a nose-down, left skid-low attitude (Figure 3).

The high-speed impact in a nose-down, left-skid-low attitude indicated that the pilot collided with terrain with substantial energy consistent with delivery of engine power to the rotors and at least some control. The analysis following examines the circumstances of the occurrence to identify the contributing factor(s) and any safety implications.
